## WORKING LIFE OF DIESEL ENGINES: A RETROSPECTIVE ANALYSIS

### ABSTRACT

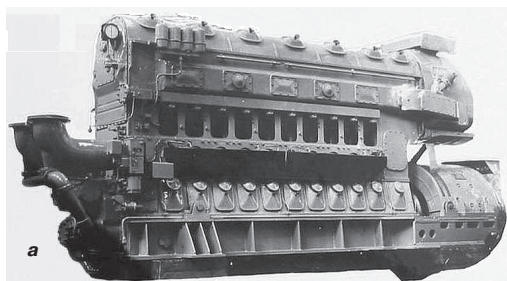
**a** – general view: 1 – upper shaft crankcase; 2 – lower shaft crankcase; 3 – vertical transmission compartment; 4 – solid displacement blower pump of ROOT type.

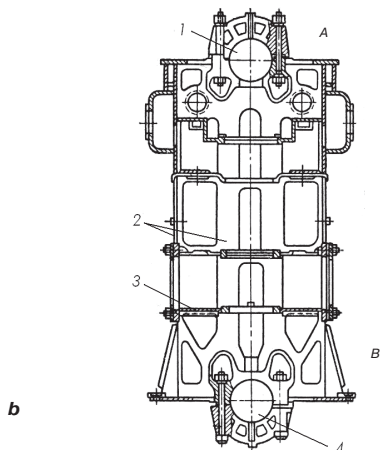
**b** – block of diesel engine, a cross-section: 1 – suspension node of the upper crankshaft; 2 – vertical sheets; 3 – horizontal sheets; 4 – suspension node of the lower crankshaft; A-B – places of cracks formation.

In the initial period of operation cracks were observed in welded seams, running into studs of the block, the most common damages were observed in connection node of indigenous supports (straps) of crankshafts with upper and lower horizontal plates of the block (Pic. 1b – A), in the anterior vertical sheet of control unit and in the place of coupling of the inclined and vertical plates with the bottom band (Pic. 1b – B). A residual deformation of the crankshaft bearing points was observed, wherein misalignment of the upper line of the crankshaft reached 0,18 mm [9, 10].

Subsequent overhauls revealed that at least 30% of diesels, arrived for repair, had inherent deformations of strain bearing of crankshafts (curvature of the shaft line, misalignment and crack). Damages were located closer to the support units of the crankshaft, horizontal sheets adjacent thereto (30% of cracks), and primarily – to the structural elements that received the load of the vertical transmission (50%). Attempts to strengthen the structural elements of the block, to improve the quality of boiling of seams did not bring the desired result, they only reduced the severity of the problem.

Thus, it had been found that the most loaded and damageable elements in cylinder blocks of diesel 2D100 were nodes of hanging upper and lower crankshafts with adjacent horizontal plates and vertical transmission compartment.

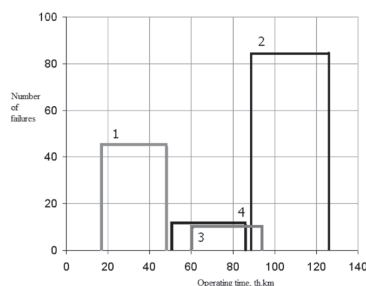
**Pic. 2. Failures of pistons of 14A variant of diesels 2D100 (data [5]):**

**1** – cracks on streams; **2** – network of cracks of the bottom; **3** – through crack at the bottom; **4** – destruction of piston.

The test results were discouraging: netting of cracks similar to the one that was in the initial version, was observed at the pistons of all options. Moreover the engineers observed cracks on the streams to accommodate the piston rings (14A, 14B), internal cracks – on the edges of the head (14B), through cracks – at the bottom (14A, 14B), and other types of damages [5, 6]. For pistons of 14A type, for example, a net of cracks (82 damaged pistons, or 54%, Pic. 2) became apparent at a sufficiently high operating time – more than 90 th. km, which indicated a periodic overheating and accumulation on the surface of thermal fatigue damaged. Cracks on streams (46 cases, or 30%) were observed as a result of carbon deposits in the inner side cavities of the piston also due to overheating. At the same time, through cracks, damages of pistons had likely a random character.

Damages of pistons 2D100 were mostly of thermal nature: design changes were aimed at increasing the strength of the studs and their mounting, heat stability of the head, rational layout of the internal cavities for oil circulation.

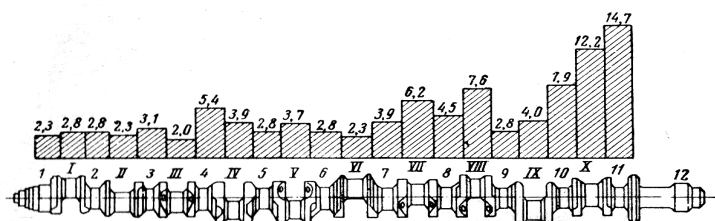
**Pic. 3. Distribution of damages of the upper crankshaft of diesel 2D100 on its elements in % of total damage [13].**  
I–X – crank journals;  
1–12 – main journals.

Damages of crankshaft were of fatigue nature, and their length distribution was fairly uniform (Pic. 3). «This uniformity indicates that the crankshaft of diesel engine 2D100 is quite equal in strength in neither by sections», as it was optimistically pointed out in [13]. Rather, it indicates that the loading conditions of the shaft all along were equally bad. The predominance of failures in the tenth crank and eleventh main journals was explained by ineffectual location of the bevel pinion of the vertical transmission causing additional shaft deflection, not compensated by its rigidity or structure of supporting nodes. A major influence on the stress-strain state of the shaft was provided, as it turned out, by the deformation of the shaft support units in the cylinder block and the presence of misalignment.

Transition fillets between the journal and cheek of the crankshaft, where the majority of cracks was formed [11], were recognized as most dangerous, as the radius of that unit was of only 8 mm. After rounding the fillet, increasing its radius from 8 to 12 mm, introduction of rolling technology, i. e. creation of compressive stress zones, which prevented the formation of sites of residual tensile stresses on the surface, the number of cracks and fractures decreased by 4,5–6 times.

The first notable step to solving the problem was to strengthen the crankshaft due to replacement of the material – (alloyed iron Cr-Ni-Mo), from which it was originally casted on, with high-strength cast iron with globular graphite. Due to this change wear decreased by several times, but it did not influence the process of cracks and breaks appearance [14]. The assumption that new crankshafts had deviations in chemical composition, mechanical characteristics and structure had not been confirmed, studies showed that the quality of broken metal of shafts of high-strength cast iron was more than good [15], and therefore, structural elements were the most dangerous.
