WORKING LIFE OF DIESEL ENGINES: A RETROSPECTIVE ANALYSIS (PART 2)

Sirotenko, Igor V., JSC «VNIIZhT» (All-Russian Scientific Research Institute of Railway Transport), Moscow, Russia.

Gogrichiani, Georgy V., JSC «VNIIZhT» (All-Russian Scientific Research Institute of Railway Transport), Moscow, Russia.

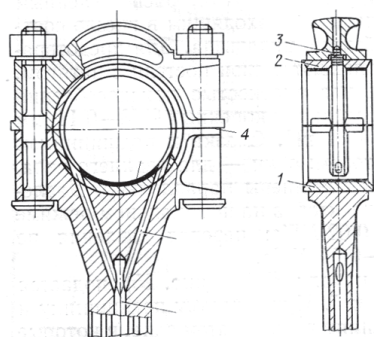
Pic. 1. Lower head of the crank rod of the diesel 10D100: A – sloping channel for supplying lubricant to the piston; B – the axial channel; C – groove-less part of the bearing; 1 – insert with a partial groove; 2 – insert with an annular groove; 3 – pin; 4 – connector.

Another drawback was the increased number of failures within node «crankshaft-bearing». During 1963–1967 a number of diesels 10D100, on which scratches of rod and main bearings were observed, amounted to 10% of in-service bearings [9]. Loads on the bearings of the engine were increased by 1,5 times as compared to less forced 2D100, and the deterioration of working conditions contributed to the unfavorable, badly bedding in metal structure of the necks of the shaft of ductile iron.

What is the design of the bearing? It included suspension of the crankshaft, lower head of the crank rod had flat connectors (Pic. 1, position 4), characteristic of the early designs of engines (first generation), in more recent designs the connector due to insufficient stiffness was transformed into ridged: the spline joint with an angle at the vertex from 60° to 90° . The bearing had a sufficient high-ratio of main design parameters of width and diameter – a necessary condition for enabling work, in its middle part there was an annular groove. Inserts had soft, easily bedded in and relatively quickly worn coating of babbitt BK-2.

Designers decided: axial channel B in the crank rod pin, through which oil was supplied to the piston, was drowned, instead of it two inclined channels A were drilled, which went to the annular groove, and thus in the center of the insert zone without groove was formed B in [9, 10]. Due to increased area of the working surface of the bearing, the minimum film thickness increased by 1, 5–2, 5 times. In addition, treatment of surface of crankshaft journals Rz was increased from 8–9 to 4–6 microns. These steps fully reduced tendency of a bearing to be scratched. In addition transition was performed to the engine oil M14V with a higher kinematic viscosity of 14 cSt as compared to the previously used (12 cSt) [11].

We can say that the most important acquisitions were the development of the working surface of the bearing (the exclusion of the groove in the center), improvement of treatment of surface of crankshaft journals, the transition to higher quality engine oil.

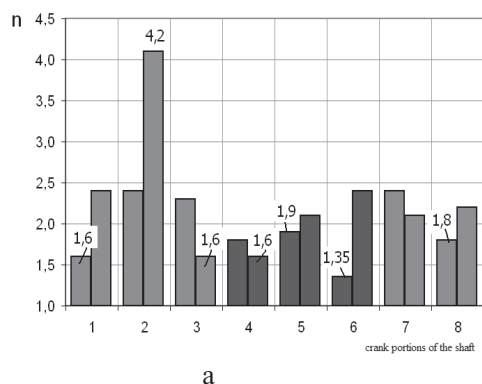
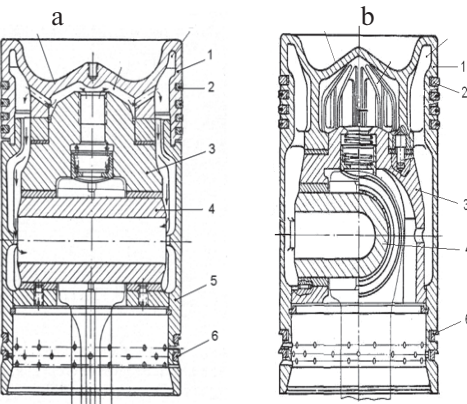
Pic. 2. The piston of the diesel 11D45: a) the original design (1959); b) solid-cast design of VNIIZhT. 1 – head; 2 – compression ring; 3 – insert; 4 – piston pin; 5 – trunk; 6 – scraper ring; A – bottom, B – inner cavity, C – side pocket.

The main problem of the new second-generation diesel engine 11D45 were failures of pistons. In calculation per one engine from 6,5 to 11 pistons (of sixteen) were replaced annually, the maximum outturn fell to the mileage of 150–200 thousand km [11]. The main reason for failures (about 80%) was associated with the development of cracks along the ridge of the bottom of the piston head, the so-called «pockets» and sickle through cracks like in the pistons of the option 27 [4, 12].

The initial design of the piston is composite (Pic. 2a), the head was made of ductile alloyed cast iron Mg (1), a trunk was made of an aluminum alloy (5). It was cooled by circulating oil supplied through the apertures of the crank rod into the central upper cavity, then into cavities at the edges of the head.

At the first stage of modernization oil supply was improved, the head of the piston was made of heat-resistant steel 2X13 instead of cast iron, however, it was not possible to significantly reduce failures. As a temporary solution the order was introduced in which heads were replaced forcefully at the run of 125–150 thousand km. Work on the pistons were resumed in the early 1970s. An improved piston was structurally quite different from the original (Pic. 2b): wall thickness of the piston head (A) was re-

duced, the central cavity (B) was significantly increased by reducing the size of the chamber, finning was made, volume of cavities- pockets (B) was increased. Motor oil with antivarnish additives (M14VTS) came into use, which contributed to the improvement of the thermal state of the pistons.

Designers, apparently, did not follow the ways of increasing the heat resistance of the material of the head, but applied thermally conductive material – alloyed cast iron and provided more heat dissipation due to more effective inertial head cooling [13, 14]. In the new piston (Pic. 2b), the head and trunk are molded together, because there is no need in heat-resistant alloy. There are similar pistons of Kolomna Plant for diesel engines and of VNIIZhT – for repair enterprises.

So, at that time the solution of the problem of reliability of the pistons of diesel engines 11D45 was reduced to the use of efficient cooling system of the head (inertial), to increase in cavities pockets, to development of cooling surface due to finning, to use of thermally conductive material (alloyed cast iron) and anti-varnish additives for motor oil.

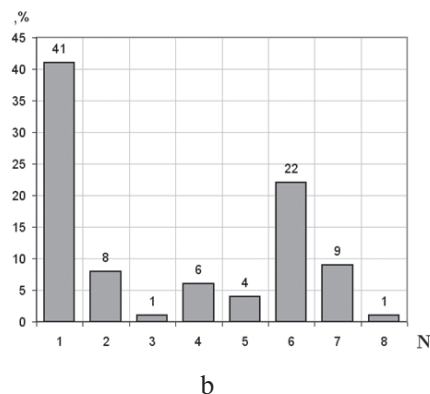
Over time, structural defects of the crankshaft became apparent in diesel engines 11D45, ultimately led to a reduction of the resource. Failures began to emerge at an operating time of over a million kilometers. The share of crankshafts, discarded during overhaul, was 16–25% of the totally received crankshafts, that is on average two to three times higher than that of the most common type diesel engines D100. The main reason (66%) is fatigue cracks and fractures on the crank pins.

As the analysis of the factors affecting the working conditions of the shaft [15] showed, the failures were caused primarily by the growing deterioration of its support units – suspensions with a gear connector. The majority of previously operated suspensions received a fatal draw of screw bolts (reduction in tightening force by 37–50%), and closer to overhaul time wear of cloves of the connector and misalignment beyond the permitted limits were observed, thus indicating a strength unsafety of the structure.

The test results confirmed that the misalignment dramatically weakened the structure of the shaft. Pic. 3a shows the values for the right and left journals of each crank portion of the shaft, out-of-alignment support groups marked in a dark color. Reserves at the endurance margin in the middle of the shaft on crank portions 1, 3, 4 fall to $n = 1,6$, on the shaft 6 – to $n = 1,35$ (Pic. 3a).

Emphasis is placed on some contradictions. The greatest number of failures (41%) falls on the first crank pin with minimal endurance margin $n = 1,6$ (Pic. 3b), twice as likely fails the sixth crank pin (22%) with $n = 1,35$, the lowest number of cases falls on the third crank pin ($n = 1,6$), the eighth ($n = 1,8$), the fifth (1,9), the fourth (1,6). In other words, with the same margin coefficient the first crank pin has maximum damage rate, the third and the fourth have minimum damage rates. More likely, the working conditions of the crankshaft were strongly influenced by other factors, by, for example, residual stresses, as mentioned above.

Surface hardening of the shaft fillet by rolling was introduced, like for shafts of the diesel D100; the position of the shaft during manufacture and repair of the unit began to be controlled by optical devices, rather than using a false shaft, which gave a great error. These and other taken measures softened the situation with damage rate of shafts, but could not solve the problem finally.

In summary, it can be noted that the analysis of the calculated and experimental data shows that a construction of the suspension mounting group with a gear connector was unpromising, for durable work of the unit «crankshaft-bearing» it was required to strengthen the suspension of the shaft, to rework it significantly to avoid deformation and wear of kinks, and to start hardening of the crankshaft, or to change the material of the shaft from iron to steel.
