ACCELERATED TINES TECHNOLOGIES FOR TRAM TRACKS

Czerlunczakiewicz, Włodzimierz, *TINES Railway, Krakow, Poland.*

The article presents a way to organize repair of a tram track in the street with a large traffic load. In connection with the special location of the facility, the key aspect in the choice of technology was a short period of work, with mandatory obtaining of high technical and operational parameters ensuring long-term and reliable operation of the rail track after reconstruction.

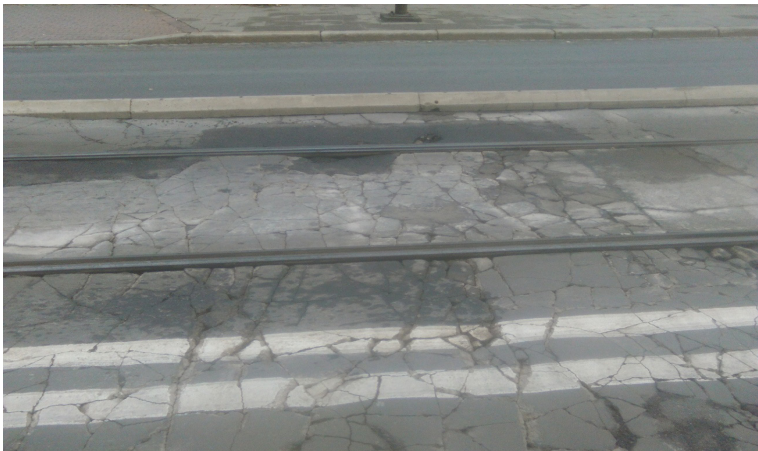
The 17-meter-long repair site included a two-track fragment of the canvas, including the cross-road. The technical condition of the rail tracks, which was inventoried during a visit to the facility by specialists, turned out to be exceptionally bad. In the existing coating, numerous cracks in the asphalt concrete were seen, as well as the separation of rubber rail elements and rail fastening elements. Damage caused water to enter the tram tracks, which accelerated the growth of chips and cracks in the asphalt concrete pavement. In some places, especially large deformations were observed as a result of the rise of concrete plates.

Pic. 1. Significant cracks and chips in the covering.

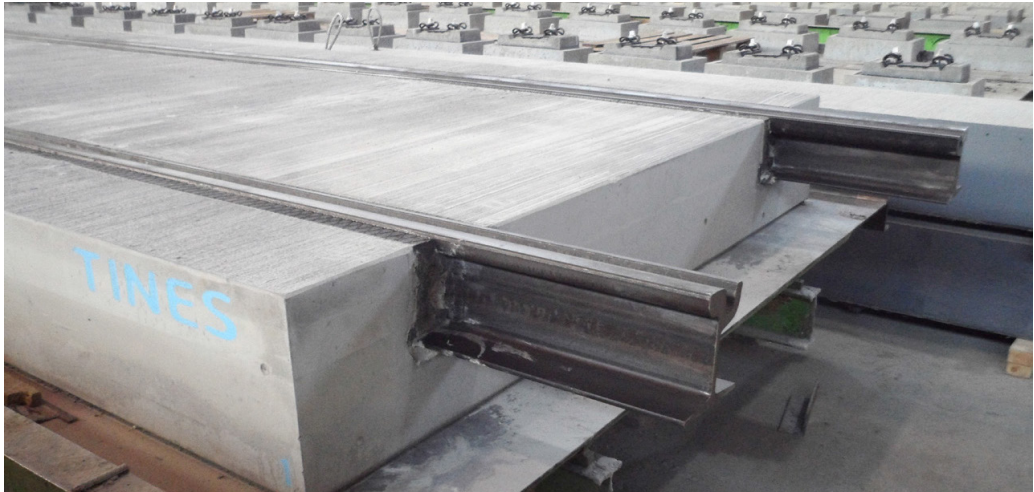
The contractor used a TINES LC–LXL type system, the main element of which is a prefabricated reinforced concrete plate 17 m long, with a built-in ERS-M module. The repair technology and the construction of tram tracks were chosen to limit the risk of a possible extension of the project implementation time. This was in line with the investor's expectations, the main goal of which was to spend not more than 60 hours to dismantle and upgrade.

Pic. 3. Factory made plate TINES LC-L XL.

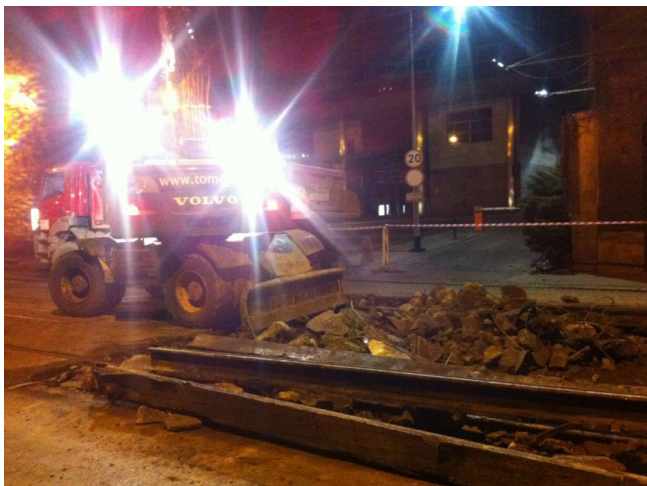
The repair of the track was planned for the weekends, taking into account the decrease in traffic intensity at this time. Construction work began on Friday, in the evening hours. After the movement was closed and the preparatory operations (including the disconnection and transfer of the contact network) were completed, the asphalt concrete, the road concrete and the base plate were disassembled. For dismantling, excavators with hydraulic hammers, backhoe loaders and dump trucks with rear unloading were used.

Pic. 6. Dismantling the existing roadbed.

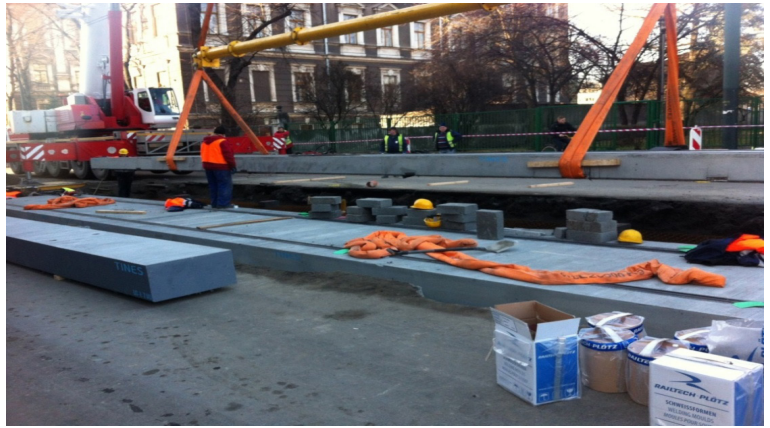
**Pic. 8. The plates of the
intertrack space of the
factory made coating
TINES LC-L XL.**

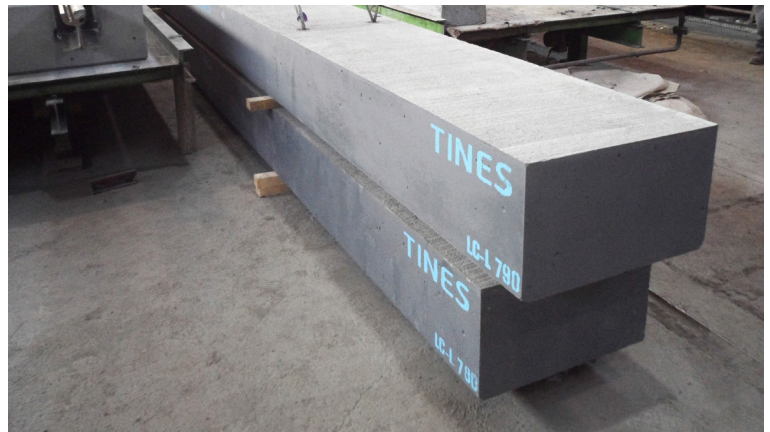
**Pic. 9. Laying the plate of
the intertrack space in the
sewerage area.**

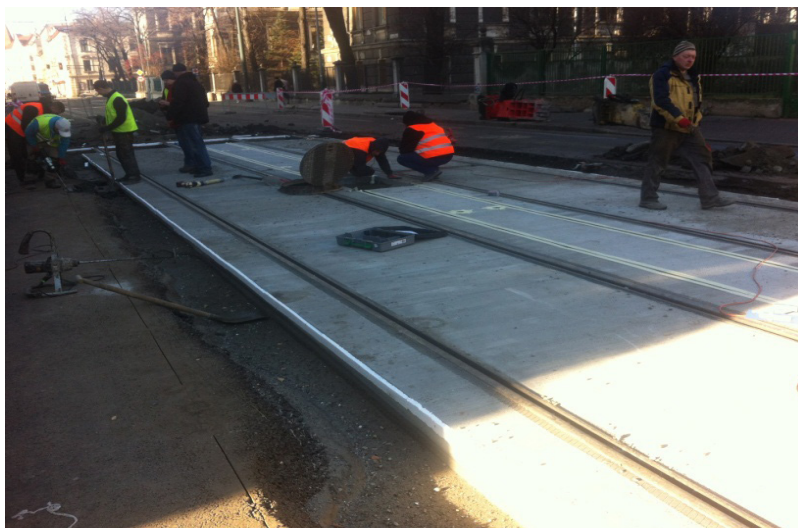
Pic. 10. Installation of polystyrene foam formwork before pouring out the concrete mix.

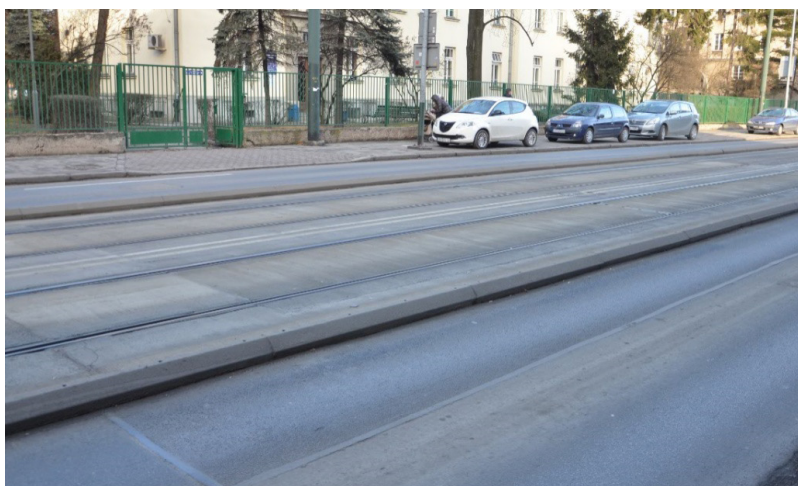
Pic. 11. Rail coating after repair with the system of plates manufactured by the manufacturer TINES LC-L XL.
