Importance of Trace Evidence Study in Determining Road Traffic Accident Circumstances in order to Prevent Insurance Fraud

As an example, the article presents an expert study of a road traffic accident that raised doubts about reliability of circumstances set out by policyholders.

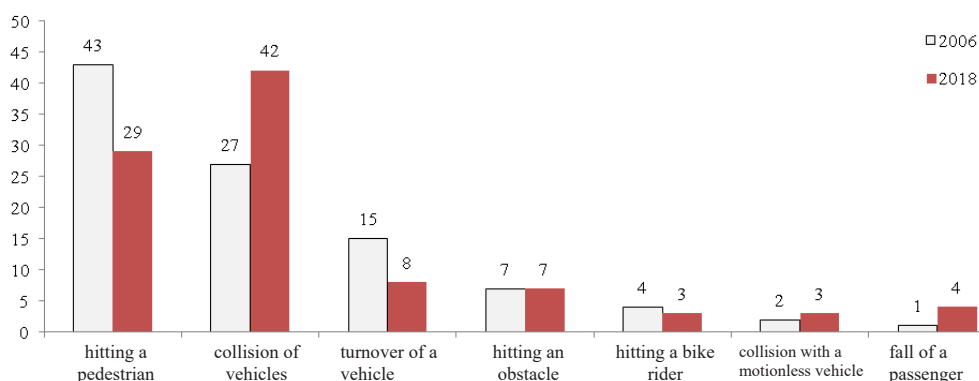
of RTA was of 25–27 %, and the most common type of accident was hitting a pedestrian (40–43 %) [3] (Pic. 1).

Pic. 1. Comparative analysis of the number of road accidents by type (2006 and 2018) in the Russian Federation, %.

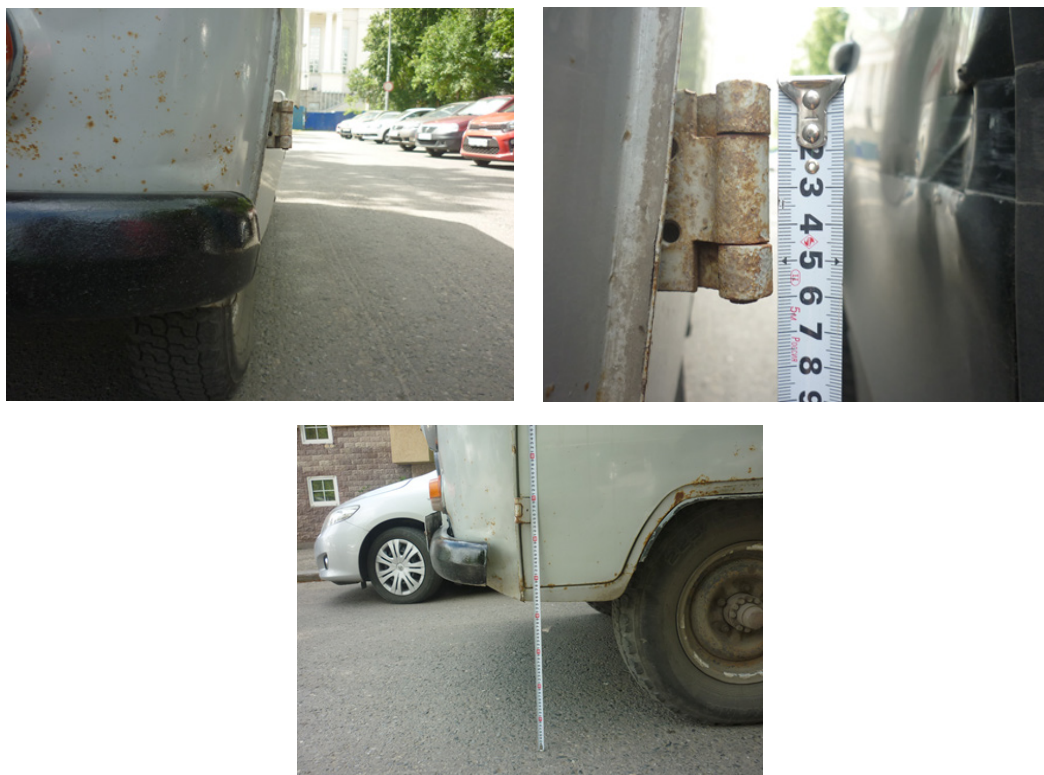
Pic. 3. Damage to UAZ-396259 car.

The most forward elements of the left side of UAZ-396259 are the lower hinge of the left door and the groove between the front panel and the opening of the left door. The lower hinge has a length of 6 cm and is located at a distance of 64 cm from the road surface. The hinge is deformed in the direction from behind to the front. On the groove at distances of 102÷103 cm and 82 cm from the road surface there are deformations formed in the rear-to-front direction. On the left door at distances of 102÷103 cm and 82÷84 cm from the road surface there are horizontal scratches formed in the direction from behind to the front. On the left front surface of the front bumper there is worn paint coating (Pic. 3).

The damage to the right mirror of BMW in terms of location relative to the road surface and the mechanism of formation corresponds to damage to the left door and left groove of UAZ-396259, located at a height of 102÷103 cm from the road surface.

The damages to the front and rear right doors and the right sidewall (rear right fender) of BMW in terms of location relative to the road surface and the formation mechanism correspond to damage to the lower hinge of the left door of UAZ-396259.

The damages to the front right door handle (including the front door lock lining) and the rear right door handle of BMW car in terms of

location relative to the road surface and the formation mechanism correspond to the damage to the left door and the left groove of UAZ-396259 located 82÷84 cm above the road surface.

The damages on the disc of the rear right wheel of BMW in terms of location relative to the road surface and the mechanism of formation correspond to the damages to the left front surface of the front bumper of UAZ-396259.

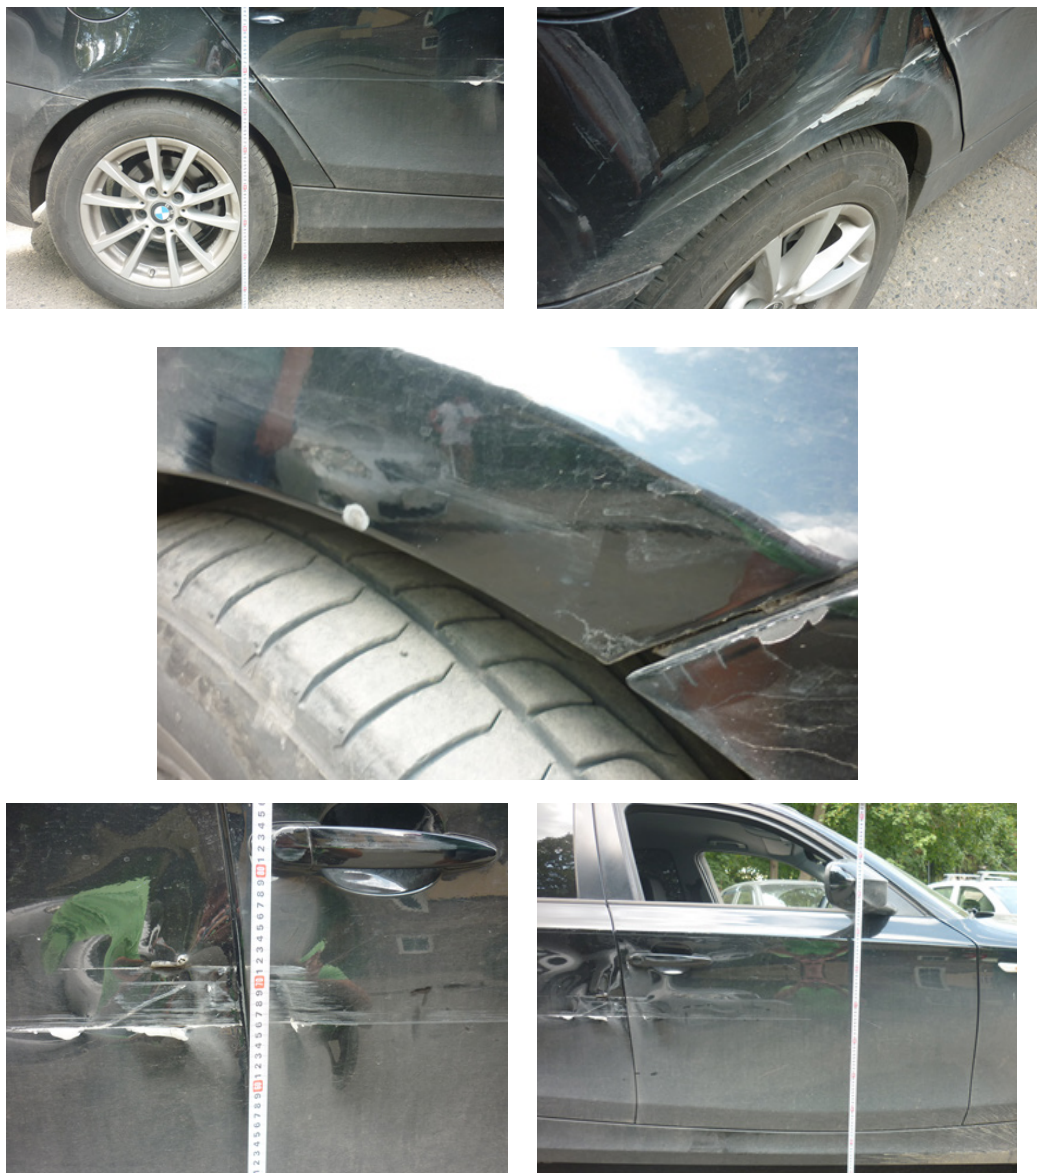
Pic. 4. Damage to the BMW car.

handles of the right doors. Damage to the right mirror is located at a distance of 102 cm from the road surface. Damages are horizontal scratches up to 2,5 cm in length on a section about 1 cm wide, formed in the direction from front to back.

Traces on the front right door start in the middle of the door at a distance of 66÷72 cm from the road surface and represent a section 55 cm long and 6 cm wide with horizontal scratches and layers of light-colored substance formed from front to back, and slight pressure in the direction of right to left with formation of a dent at the end of the trace.

Damages on the front right door handle are located at a height of 81÷84 cm from the road surface and are horizontal scratches formed from front to back with pressure to the end of the trace (on the lining of the door lock) from right to left with a layering of light-colored substance.

Damage to the rear right door is a continuation of the damage to the front right door, and starts at the front of the door at a distance of 66÷72 cm from the road surface and is a section 68 cm long and 6 cm wide with horizontal scratches and layers of light-colored substance formed in the direction from front

to back, and a slight pressure in the direction from right to left with formation of a dent on the entire surface of the door at the location of the trace and gaps in the metal in the front.

Damage to the handle of the rear right door is located at a height of about 86 cm from the road surface and represents horizontal scratches 2 cm long, formed in the direction from front to back with a layering of light-colored substance.

Damage on the right sidewall is a continuation of the damage on the rear right door, 66÷72 cm from the road surface and represents a section 68 cm long and 6 cm wide with horizontal scratches and layers of light-colored substance formed in the direction from front to back and small pressure in the direction from right to left with formation of dents mainly in the front of the sidewall and rupture of the metal at a height of 68 cm from the road surface.

Damage to the rear right wheel disc represents horizontal scratches formed in the direction from front to back (when the wheel is in the position that the damage zone is on top). The rear bumper has damage in the form of scratches located on the right side surface.

The front bumper has damage in the form of flaking paint coating on the right side surface at the interface with the fender and in the form of scratches located on the right

molding and the surface of the bumper below the molding.

The front right fender is damaged in the form of paint coating split in the front lower part (Pic. 4).

But at the same time, damages to the front bumper (including molding), front right fender, rear bumper of BMW car do not form a pair of mutually contacting surfaces with UAZ-396259, which allows to conclude that it is not possible that those damages have been formed during the road accident.

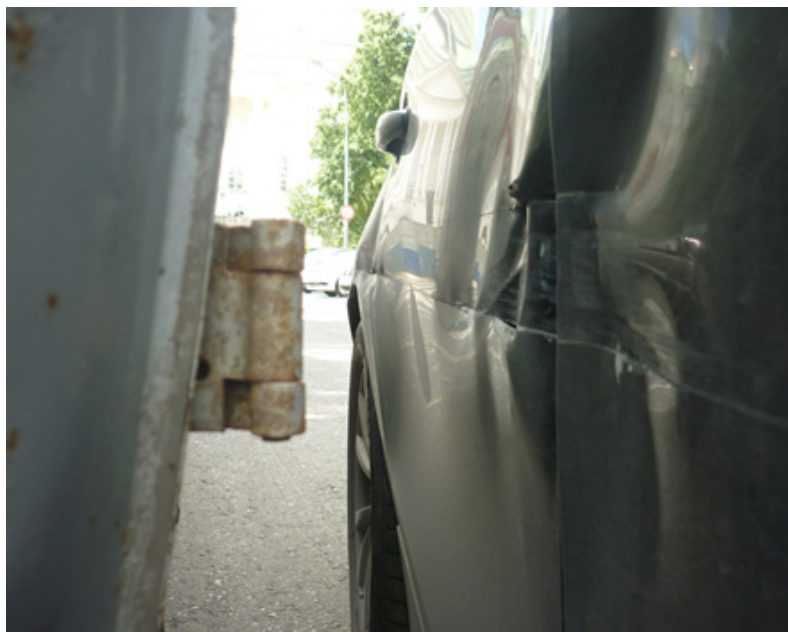
Pic. 5. Comparison of damage to the vehicles.

When comparing vehicles (Pic. 5), it was found that the damages on cars partially coincide in height relative to the road surface and the mechanism of formation. The pairs of mutually contacting parts were established [13, pp. 3–51].

- On the BMW car, damaged areas are located on the right side of the vehicle and are formed from front to back, from right to left.
- On the UAZ-396259 car, the damaged areas are located on the left side of the vehicle and are formed in the direction from behind to the front.
- The UAZ-396259 car was moving to the right of the BMW car.
- The BMW car was moving faster than the UAZ-396259 car.
- At the time of the collision, vehicles were located at an acute angle.
